Case Study 01 Stainless Steel Handrails and Street Furniture

Moderate Urban Pollution

Moderate to High Deicing Salt Exposure

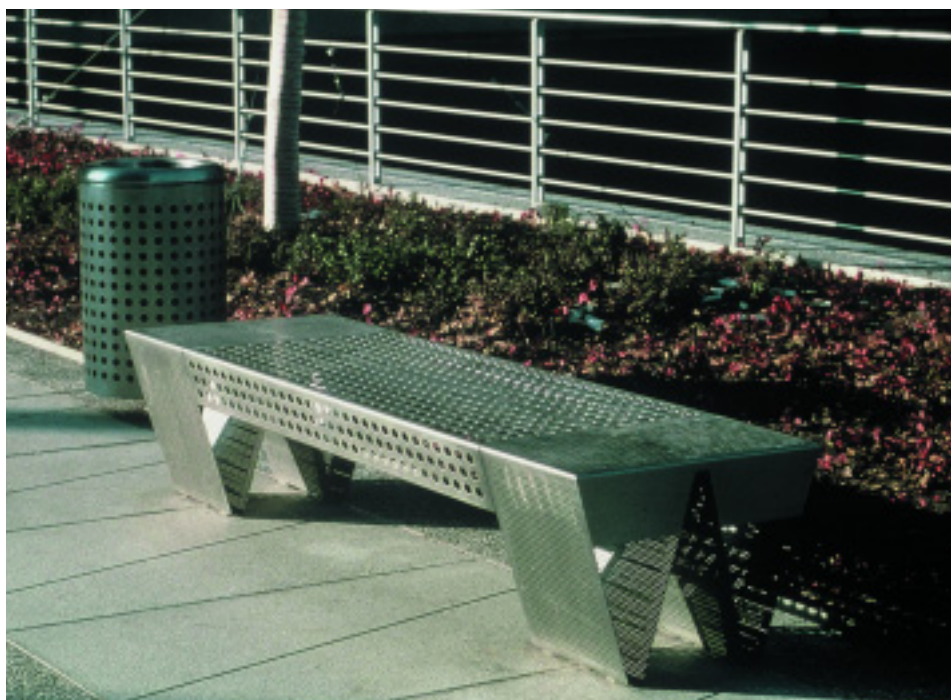
In downtown Chicago, Illinois, USA, this Type 316 (UNS S31600, EN 1.4401, SUS 316) stainless steel bench and handrail are in pristine condition after five years of service (**Figure A**). The handrail is adjacent to a sidewalk and about 1 meter (a few feet) from a busy road where deicing salt is used. The bench is in an adjoining park.

Type 316 contains 2% molybdenum, which improves pitting and crevice corrosion resistance. This is particularly helpful in preventing salt damage. The use of Type 316, a smooth surface finish, and natural rain and maintenance cleaning keep this street furniture attractive despite the severe environment.

Figure A Specification of Type 316 stainless steel, a smooth finish and a design that takes advantage of rain washing keep this bench and handrail beautiful. (Photo credit – Paul Pittsford)

Type 316 is usually the most cost effective solution for street level applications where deicing salt is used, particularly if a smooth surface finish is specified and salt deposits are washed off manually after the last snowfall of the season or if heavy rains can wash the surface. The Chicago bench and railing scores differ in two of the evaluation categories above but both have a total score of 3 making Type 316 an appropriate material choice.

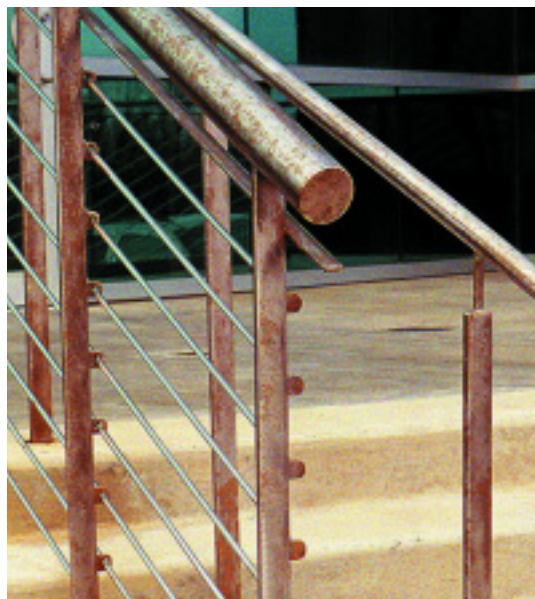
Figure B Type 304 stainless steel with a rough finish was the wrong choice for handrails exposed to deicing salt laden road mist. Cleaning will remove the staining but it will reappear every year. (Photo credit – TMR Stainless)

In contrast, Type 304 (UNS S30400, EN 1.4301, SUS 304) stainless steel handrails were corroded and badly stained after only one winter in Pittsburgh, Pennsylvania, USA (**Figure B**). The railings were installed the preceding autumn. Type 304 does not contain molybdenum and is therefore more susceptible to chloride corrosion than Type 316.

The railings are located approximately 90 meters (300 feet) uphill from a busy highway. No deicing salt was used on the steps beside the railing. Wind has carried road mist, laden with deicing salts, up the hill and, deposited it on the railings.

The tubing was purchased with a mill finish. During fabrication, a coarse abrasive pad was applied to the surface producing a rough, directional, brushed appearance. The same procedure was used for the bar. Only the small diameter rods have a smooth finish which is why they have significantly less corrosion.

Salt and corrosive pollutants more readily adhere to rough surfaces and even regular heavy rain may not completely remove deposits. The use of rough surface finishes increases the probability of corrosion damage.

Type 304 will stain and corrode when exposed to deicing salt. Refinishing the railing to obtain a smooth finish which minimizes deicing salt accumulation ($\leq R_a$ 0.5 μm or 20 μin) could reduce the Pittsburgh score to a 2, indicating that 304 can be considered. Alternatively, the railing could be cleaned regularly. Even with a smoother finish, there may be some corrosion staining of Type 304 over time and occasional cleaning may be required. If airborne dust in the warmer months contains measurable salt levels, more frequent cleaning may be necessary.
