Case Study 02 Stainless Steel Exterior Wall Panels and Window Frames

Moderate Urban Pollution

Moderate Deicing Salt Exposure

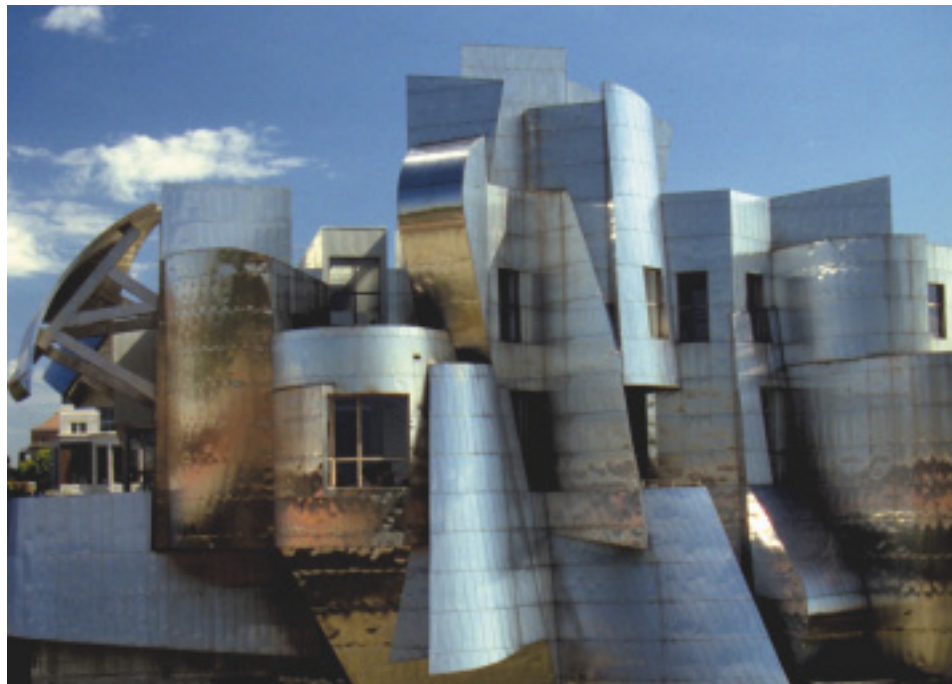
The Frederick R. Weissman Art Museum in Minneapolis, Minnesota, USA adjoins a major road and bridge where deicing salts are used (**Figure A**). Frank O. Gehry, the building's architect, recognized the corrosive nature of the environment and selected Type 316 (UNS S31600, EN 1.4401, SUS 316) stainless steel wall panels (**Figure B**). Type 316 contains 2% molybdenum, which improves pitting and crevice corrosion resistance. This is particularly helpful in preventing salt damage.

Figure A (above) Type 316 stainless steel with a smooth surface finish and a design that encourages rain cleaning was the right choice for the Weissman Art Museum. Although it is beside a busy road where deicing salt is used, there is no corrosion. The color of the building changes constantly as it reflects the surrounding environment.

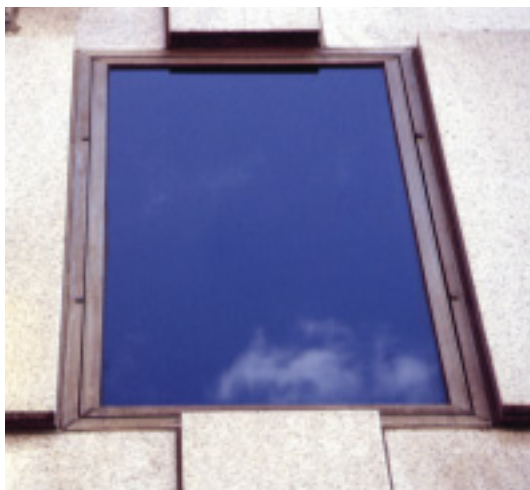
Figure C This Type 304 stainless steel window frame has not been cleaned in five years. Type 304 that is exposed to deicing salt must be cleaned regularly to remove corrosive deposits. Even with that precaution, some staining may occur between cleanings. (Photo credit – Nickel Development Institute)

The Type 304 (UNS S30400, EN 1.4301, SUS 304) stainless steel window frame is a few blocks away from the museum on the same busy road (**Figure C**). Both the window frame and the Weissman panel shown in Figure B have similar deicing salt exposure, are about the same distance from the road, and have smooth finishes.

When these photos were taken, it had been about five years since either the window frame or the panel was washed. The only significant differences between them are the type of stainless steel used and that the window frame is partially sheltered from rain by the surrounding closely spaced high-rise buildings.

Although the environment is identical, the appearance of these components is very different. The museum's Type 316 wall panels are in excellent condition with no corrosion and only a small amount of dirt accumulation. The Type 304 window frame is badly stained by corrosion.

Even with a smooth finish, Type 304 should not be specified in areas where deicing salts are used unless it will be cleaned frequently. In similar applications, adequate performance has been achieved by cleaning four times per year but there may be light staining between cleanings. This frequency of cleaning would lower the window score to 2 making Type 304 an acceptable choice. In applications with moderate deicing salt exposure, Type 316 stainless steel typically provides good performance if a smooth surface finish and vertical finish grain orientation are specified, surfaces are boldly exposed to rain, and there is heavy rain on a sufficiently frequent basis to remove surface deposits.
